# **SANITARY SURVEYS**

## ***From Data to Implementation***

***Simmons Island - Kenosha, WI***

Julie Kinzelman, PhD, MT (ASCP)  
GLBA  
October 16, 2012

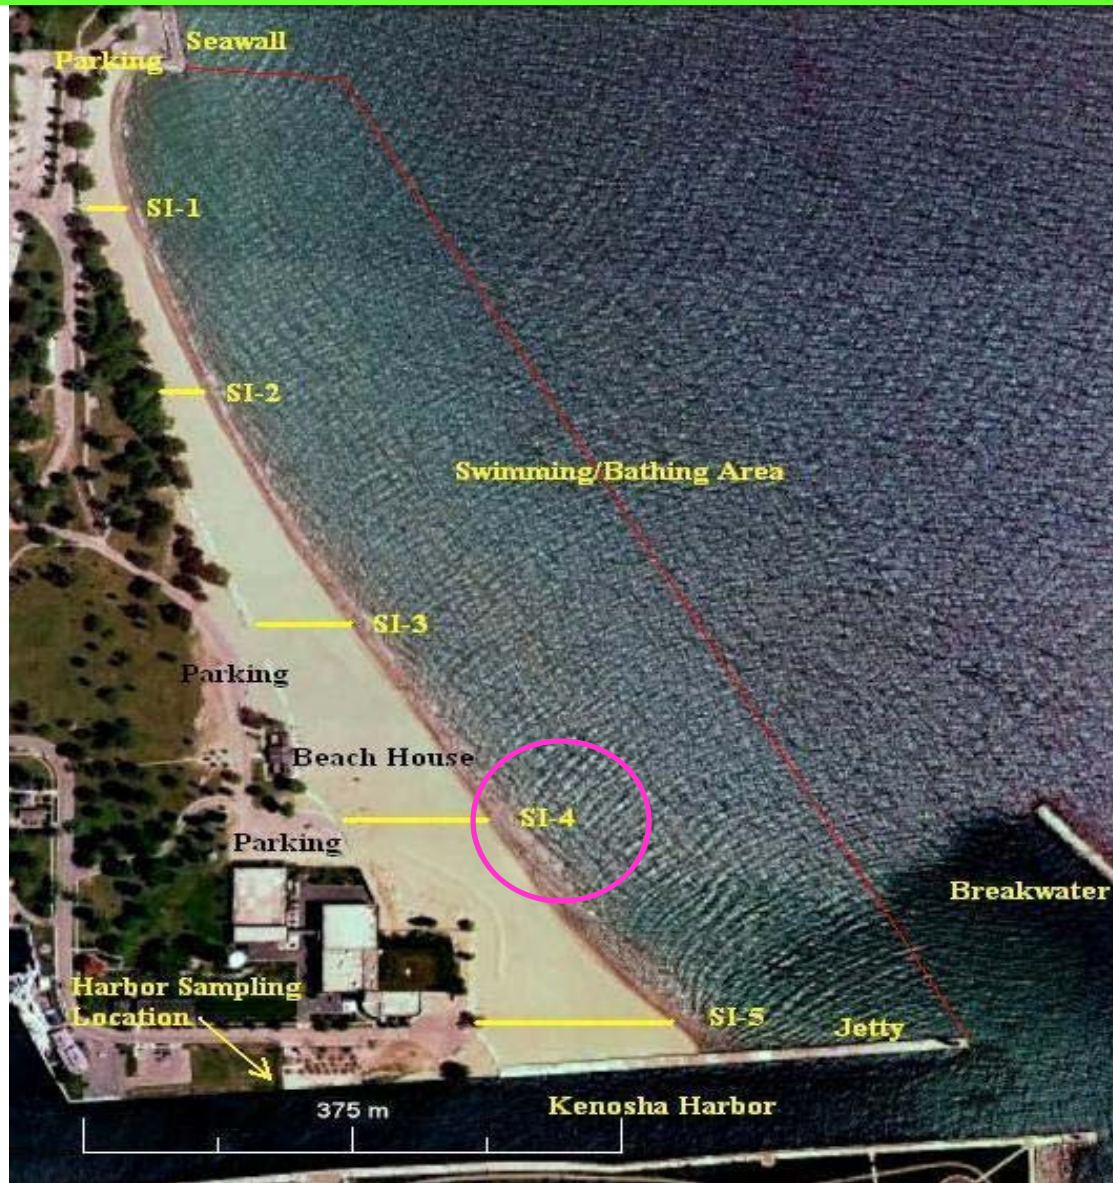
# Location of sampling transects

Sampling transects were evenly spaced when possible.

Sampling transect **SI-4** corresponds to the location where historical data was collected.

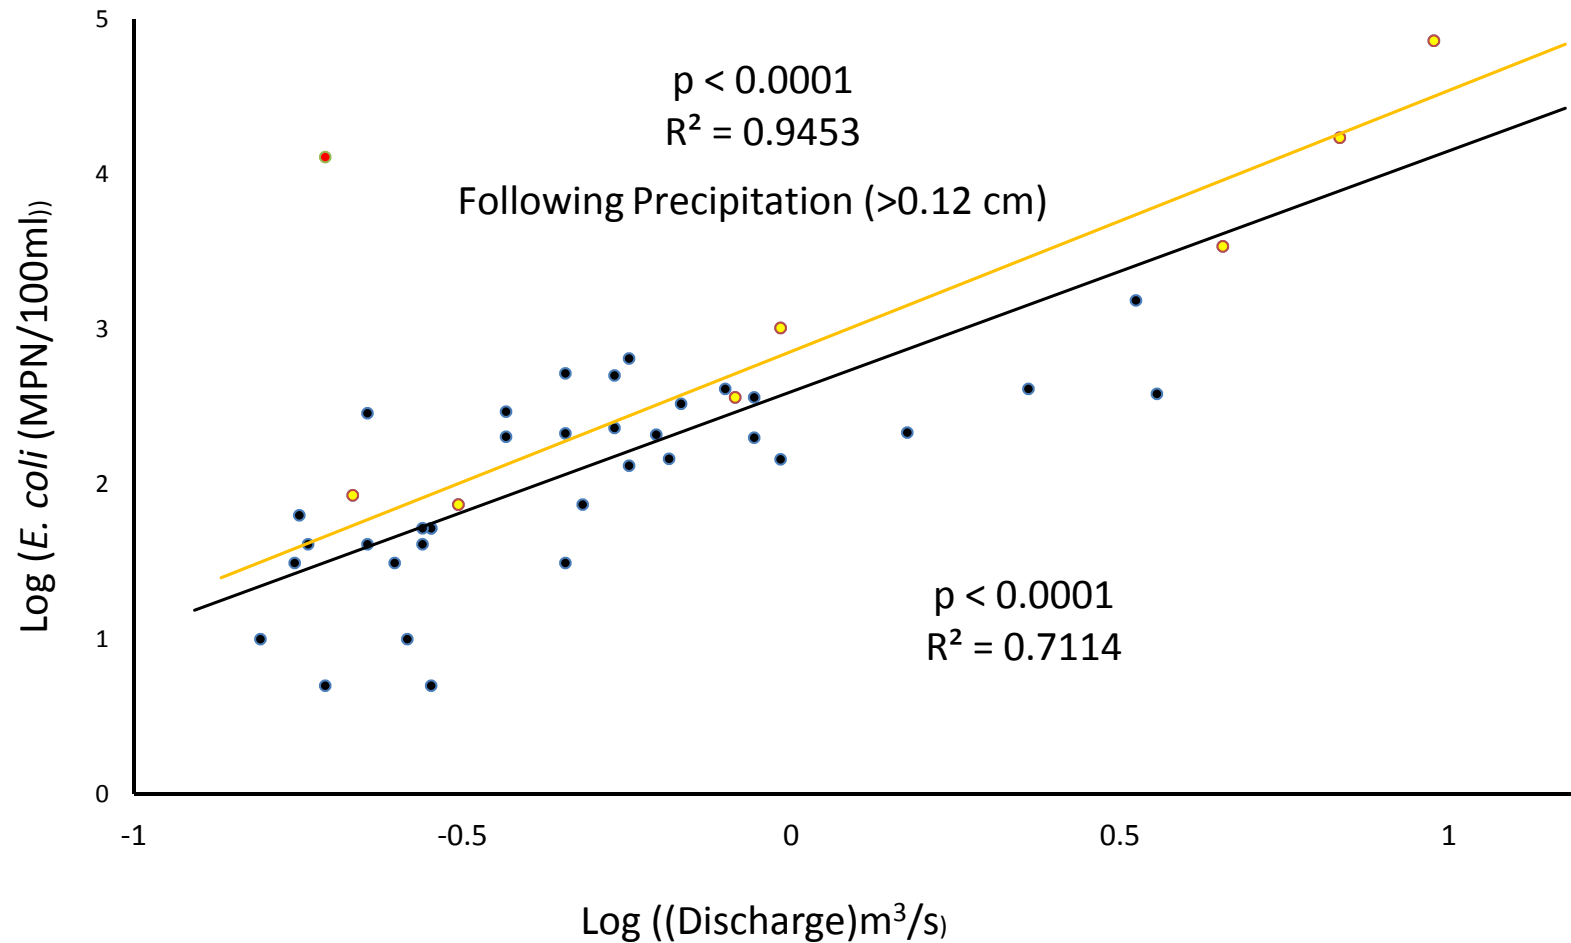
# Influence of the Pike River

- Dry Weather
- Following Precipitation (>0.05")
- 9/2/2010
- All Dates (except 9/2/2010)
- Following Precipitation (>0.12 cm)

- **Pike River behaves as a transient source of *E. coli* following rain events**
- Increases in *E. coli* concentration when larger discharge volumes were present suggests that non-point sources were largely responsible for elevated bacteria concentrations inside the river's effluent
- Upstream sources of bacteria are present and contribute to poor water quality
- Conductivity may be a good surrogate for determining the influence of the river on near shore water quality

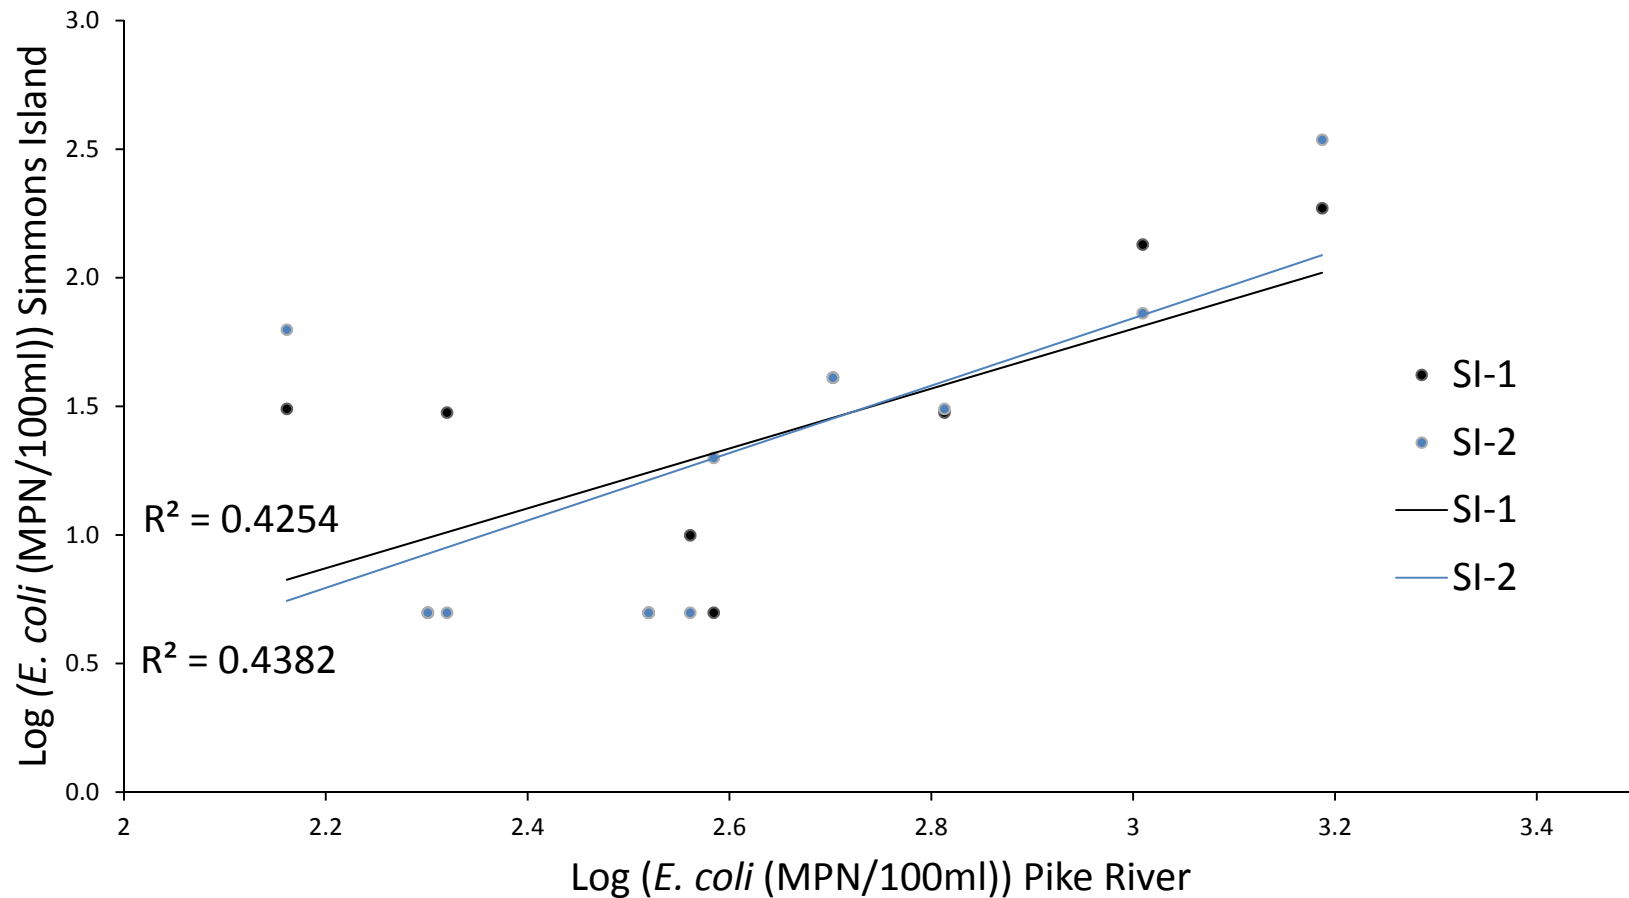
# Tributary Loading (*E. coli*)

There is a positive correlation between *E. coli* concentrations in discharge from the Pike River when a southern long shore current exists.

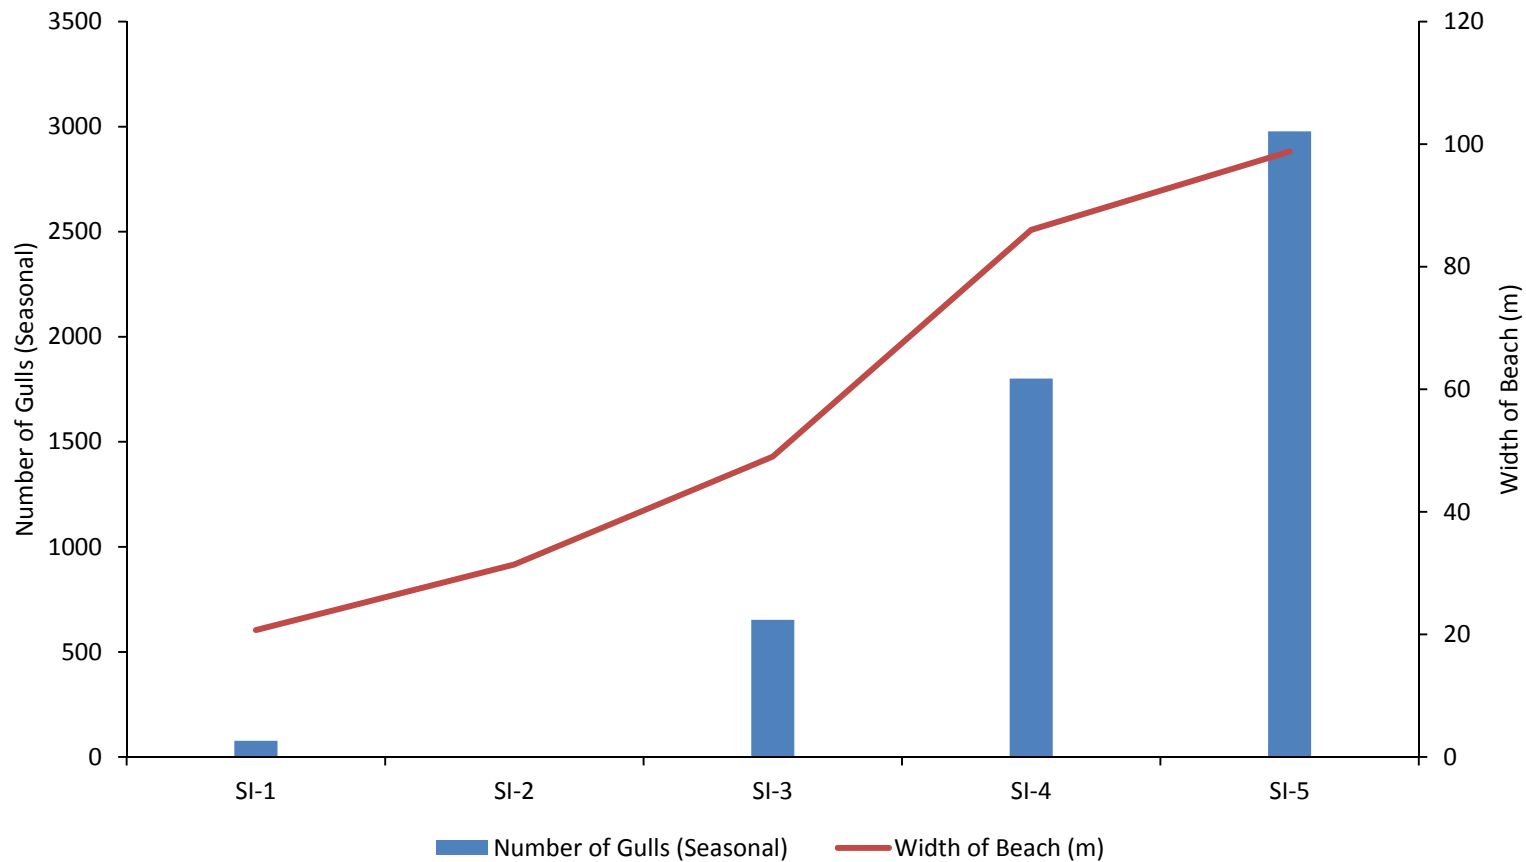
# Gulls as a Function of Beach Width

Relationship between beach width and the number of seagulls observed seasonally per transect. Seagulls appear to be attracted to the widest areas of the beach.

- Seagulls not evenly distributed
- Positive correlation between number of gulls and the width of the beach at each sampling transect ( $n=5$ ,  $R^2= 0.940$ ,  $p=0.006$ )
- Average number of seagulls observed:
  - 77 (SI-1) [northernmost]
  - 0 (SI – 2)
  - 653 (SI-3)
  - 1,801 (SI-4)
  - 2,978 (SI-5) [southernmost]

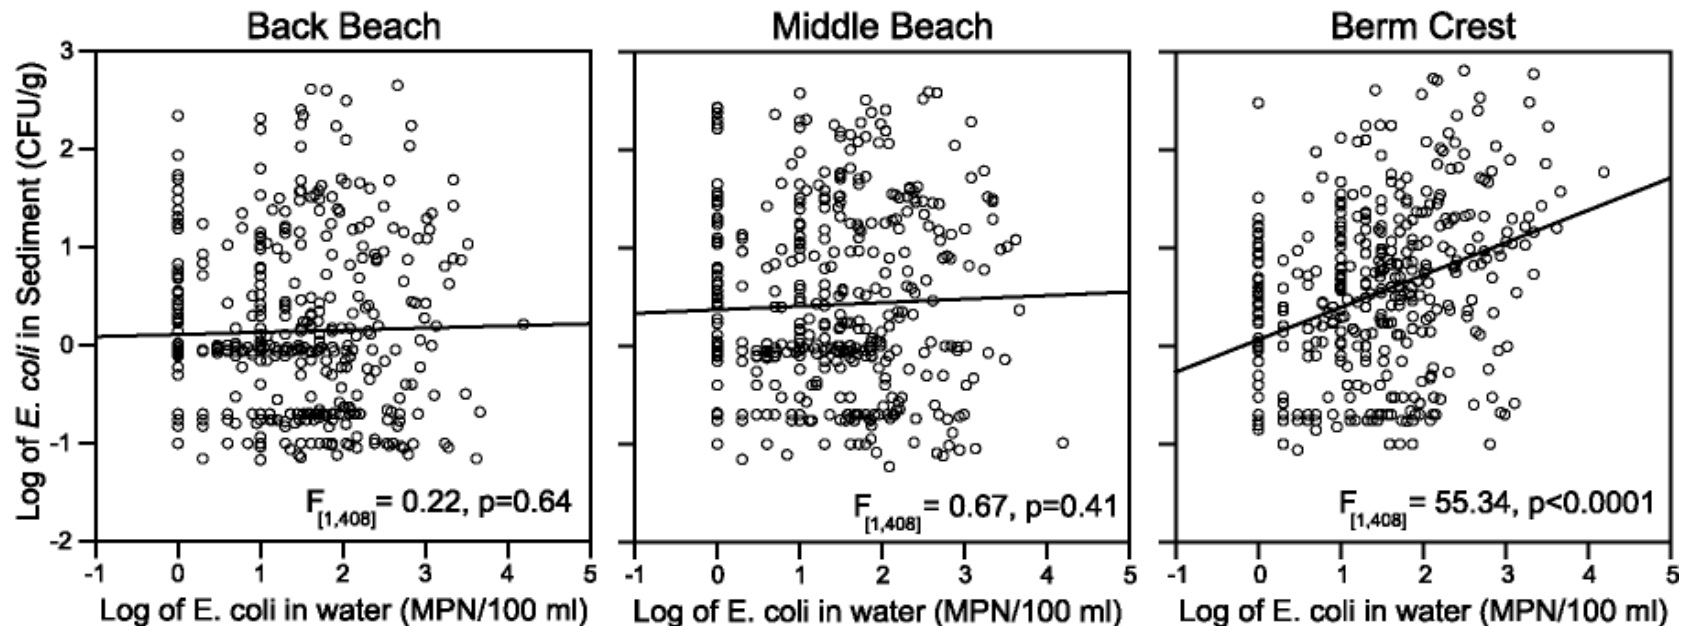
# Relationship of *E. coli* to Grain Size

Mean grain size and uniformity accounted for variation in *E. coli* density with fine sand of uniform distribution having the highest content.

*E. coli* density in surface water was correlated to *E. coli* density in beach sand samples at the berm crest.

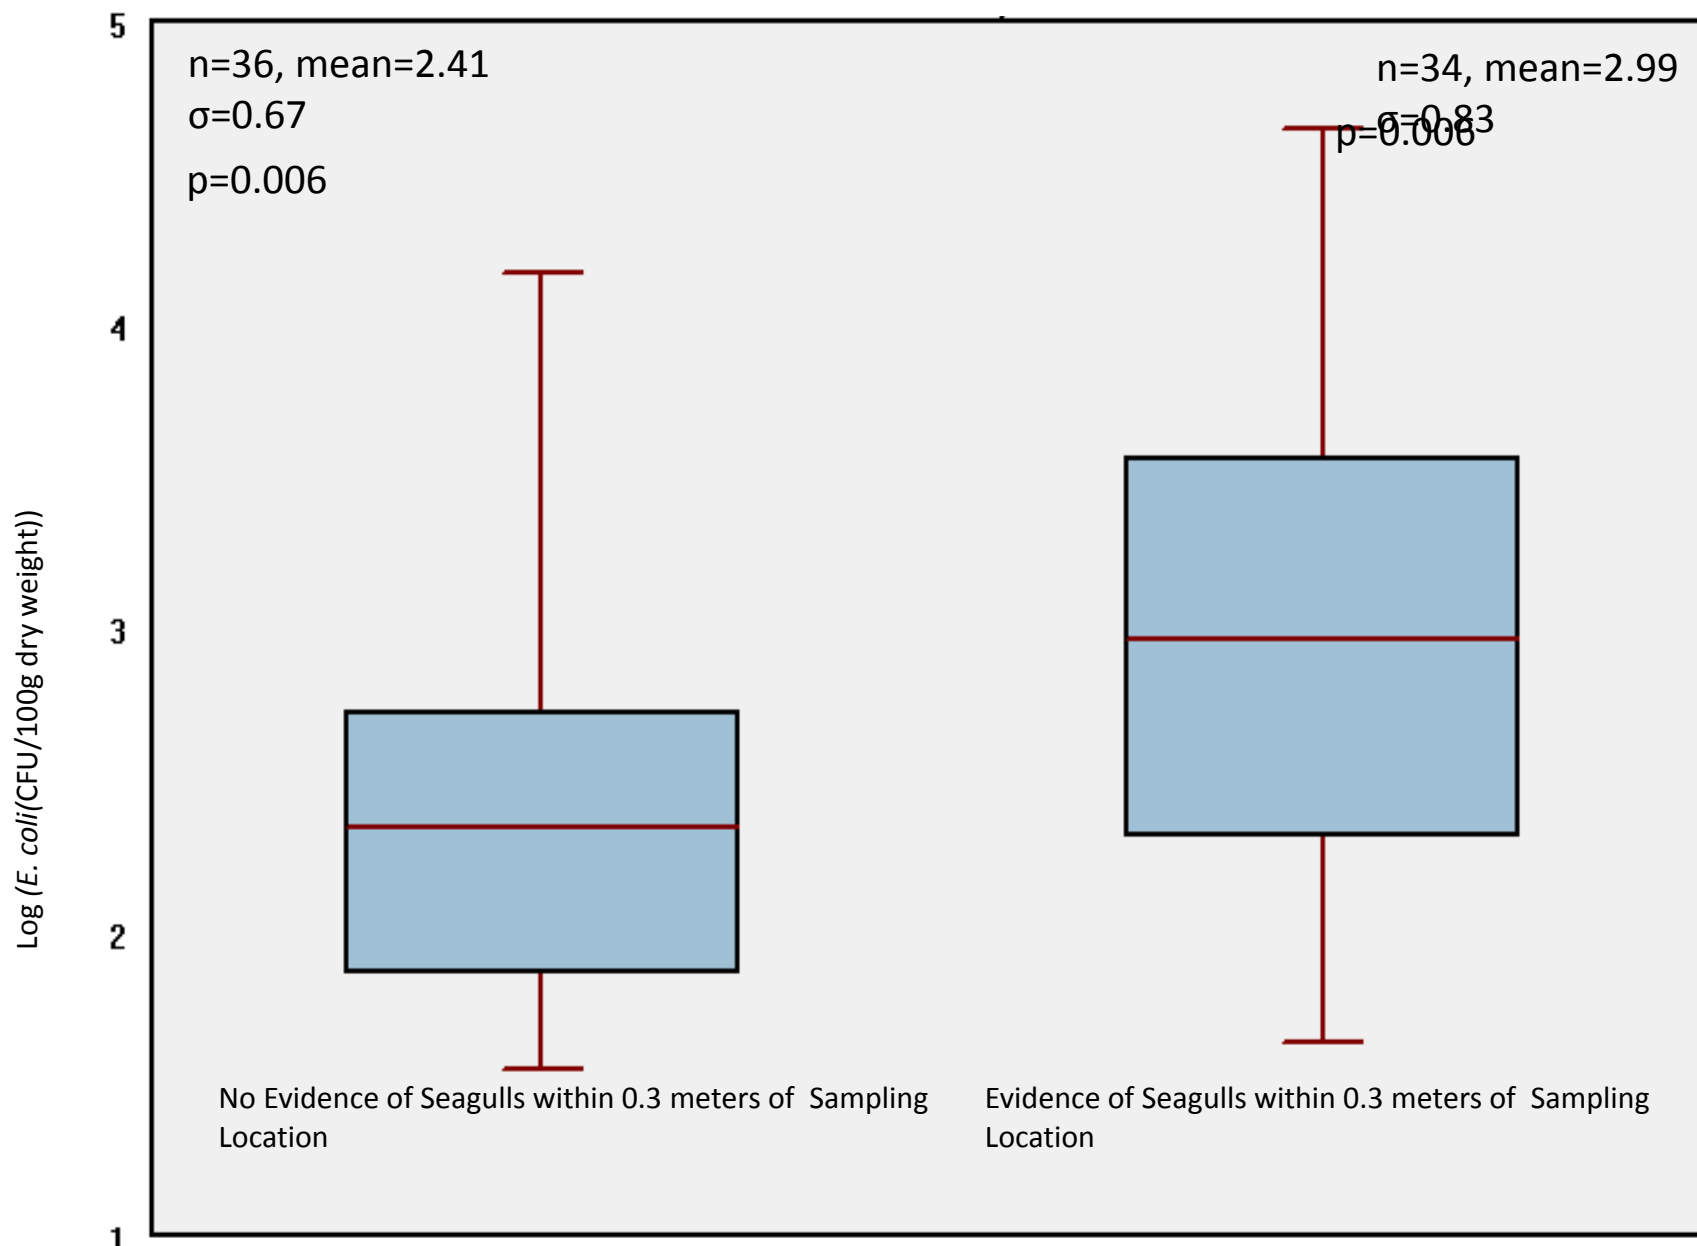
# Sediment Sampling & Gulls

Significant relationship b/w *E. coli* at berm crest and *E. coli* in near shore water, **S3 – S5 combined** (n=21,  $R^2=0.259$ ,  $p=0.0184$ )

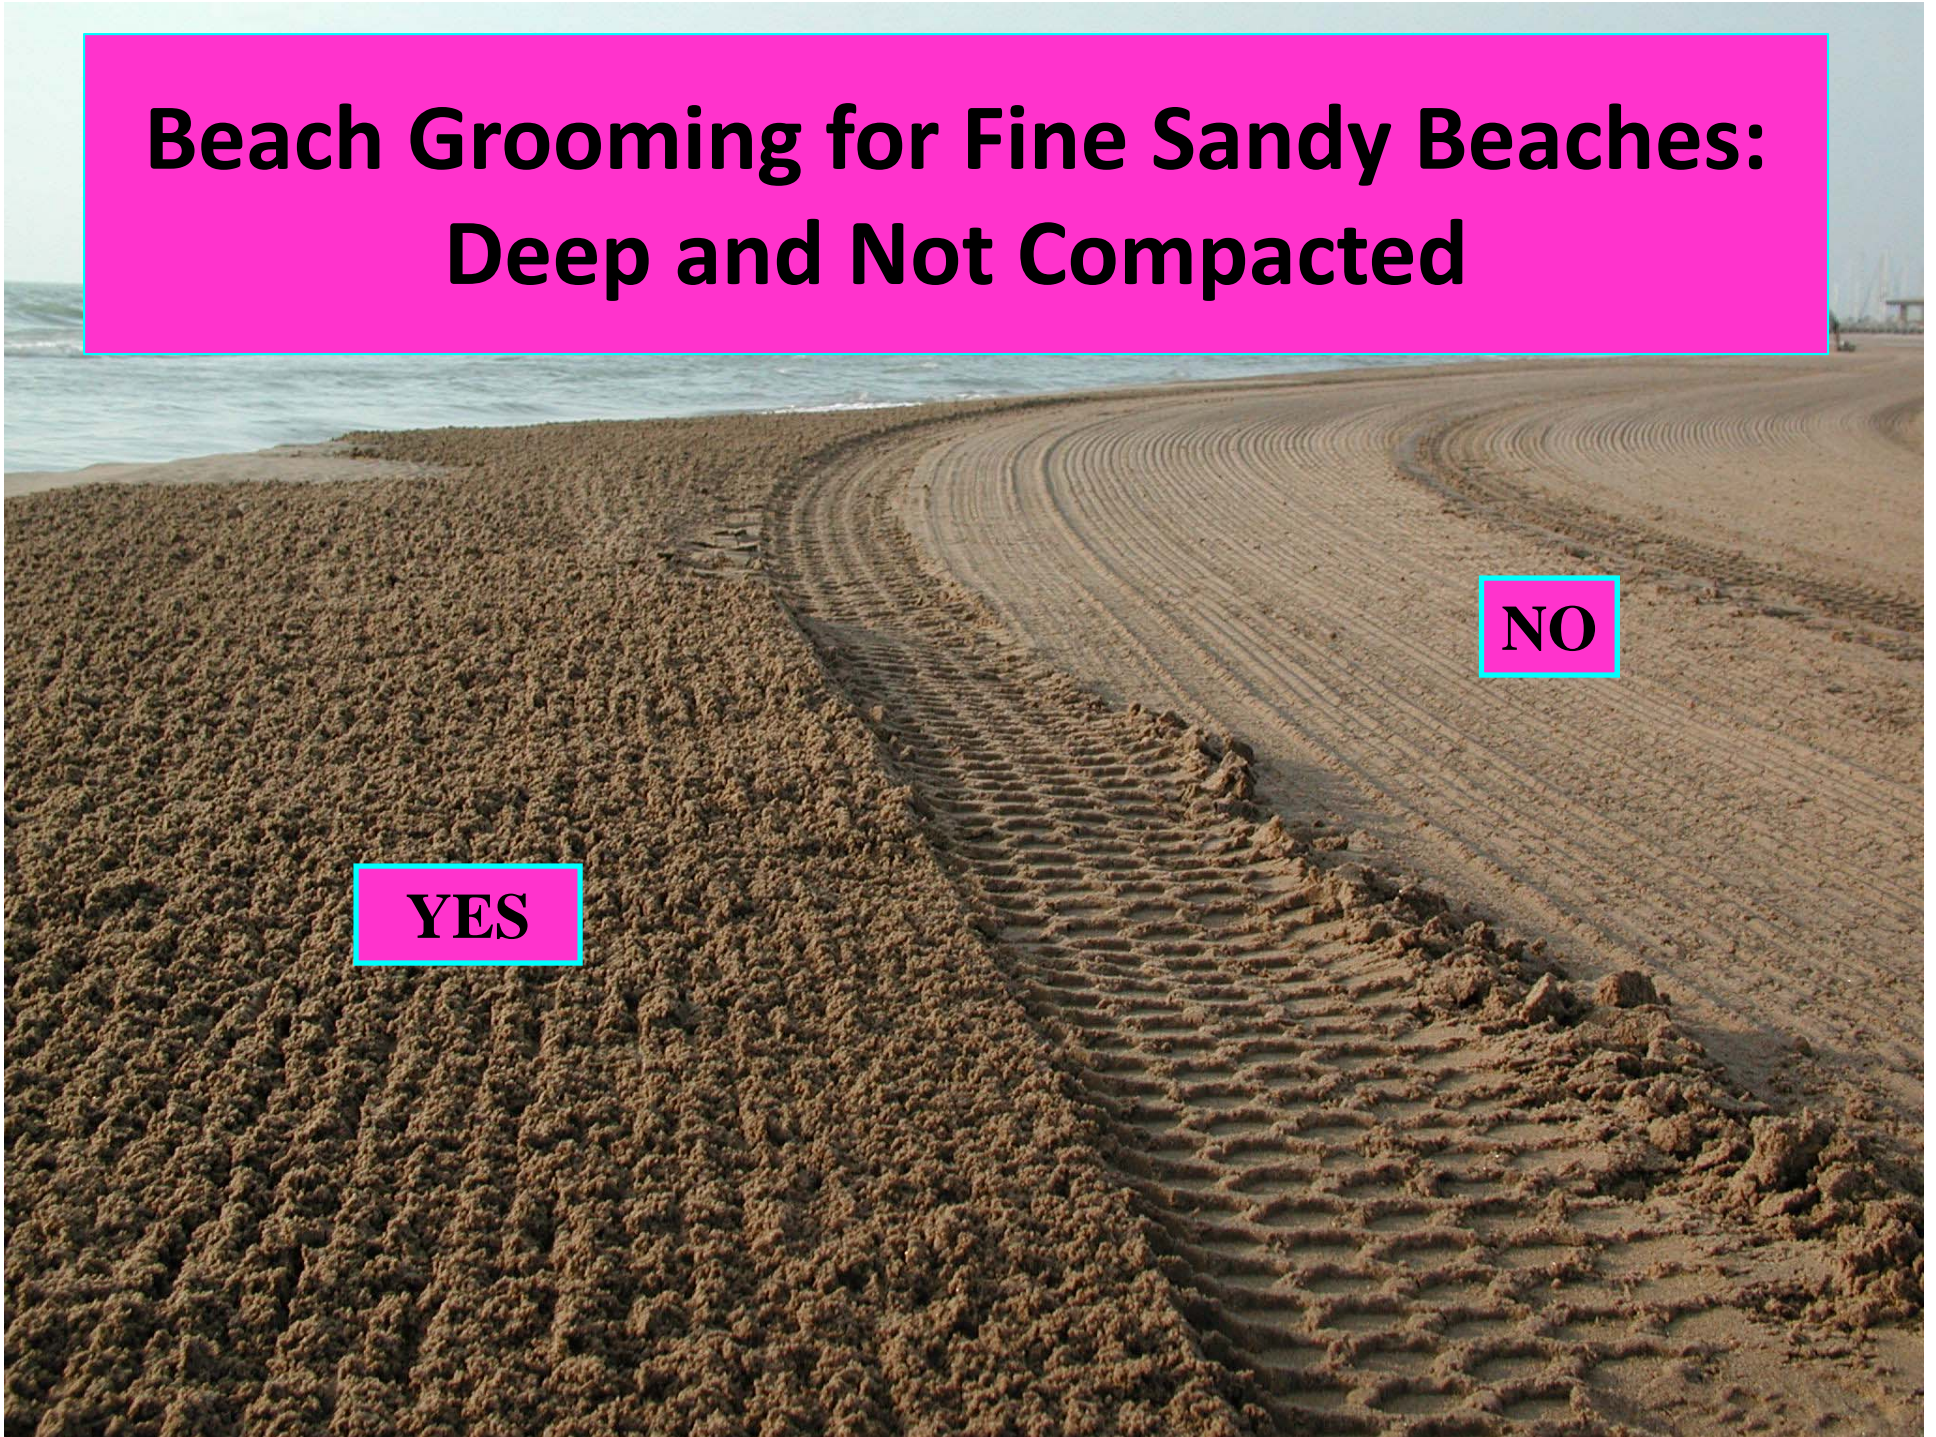
# Beach Grooming for Fine Sandy Beaches: Deep and Not Compacted

**YES**

**NO**

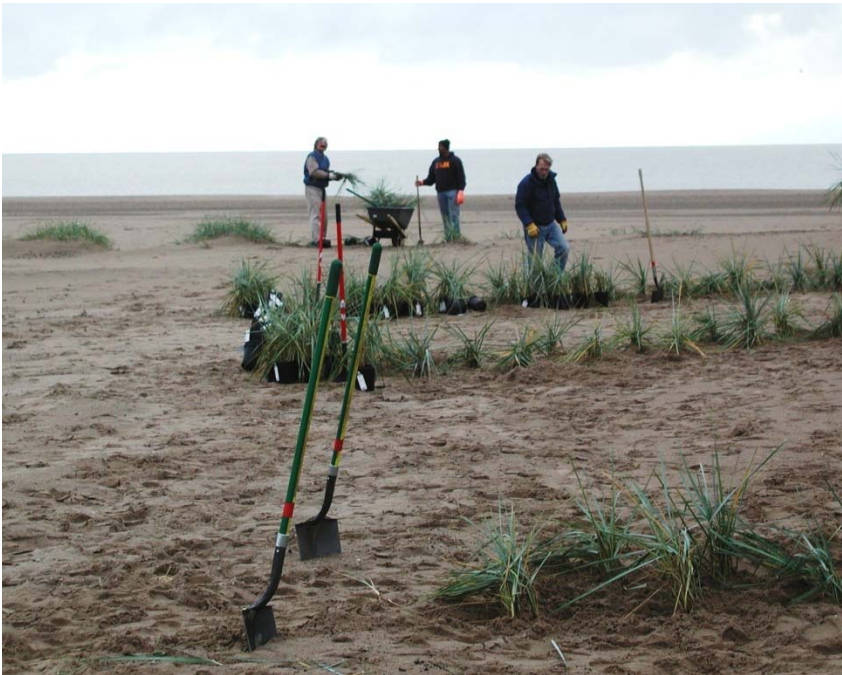
# Utility of Beach Dunes

- Capture sheet flow from paved areas
- Restore habitat
- Deter loafing gulls
- Improve beach aesthetics
- Can be constructed by municipal staff and volunteers
- Naturalized engineering
- Lower cost alternative to hard engineered structures

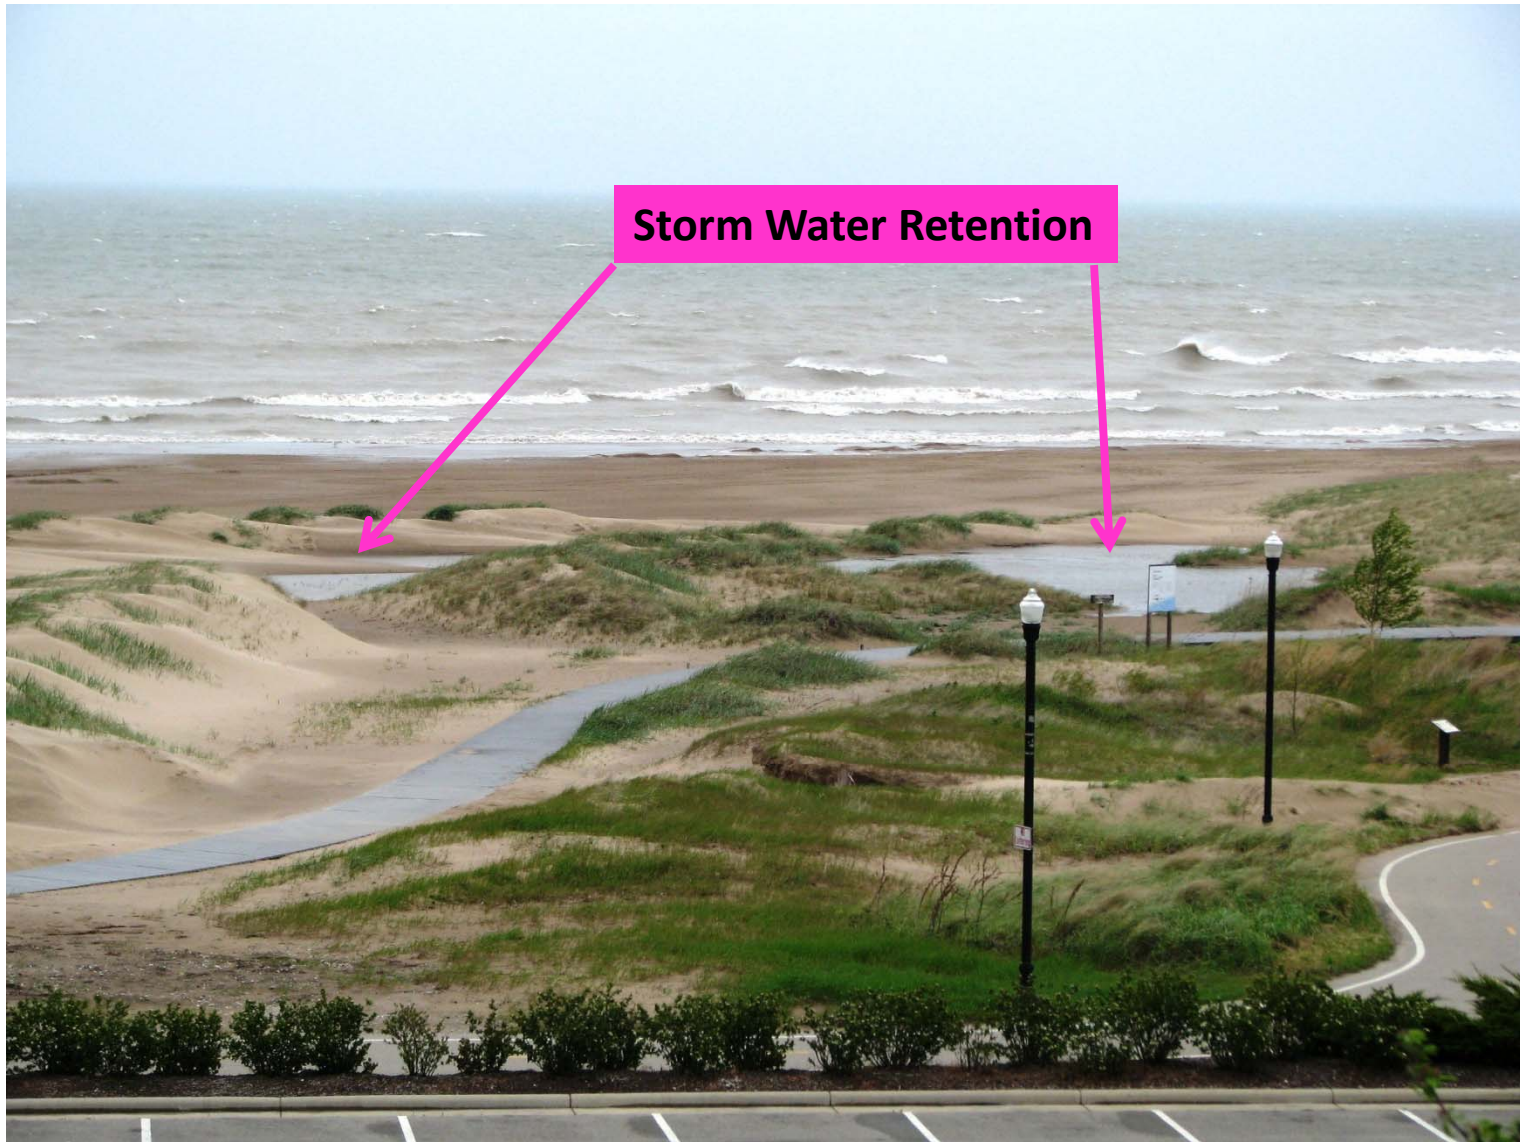
# Example of Dunes in Action

North Beach, Racine, WI

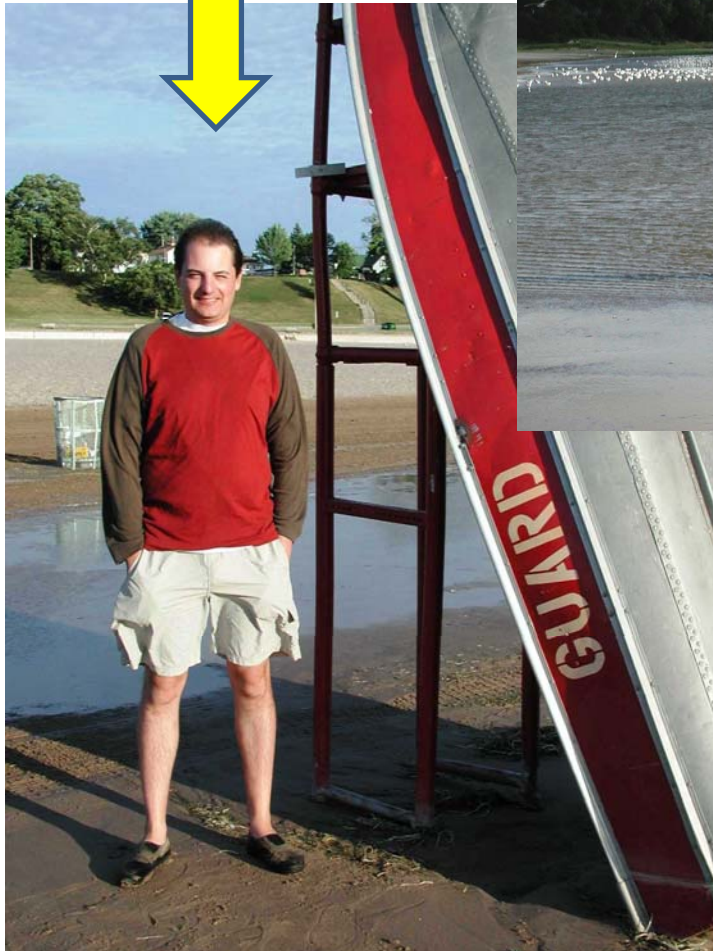
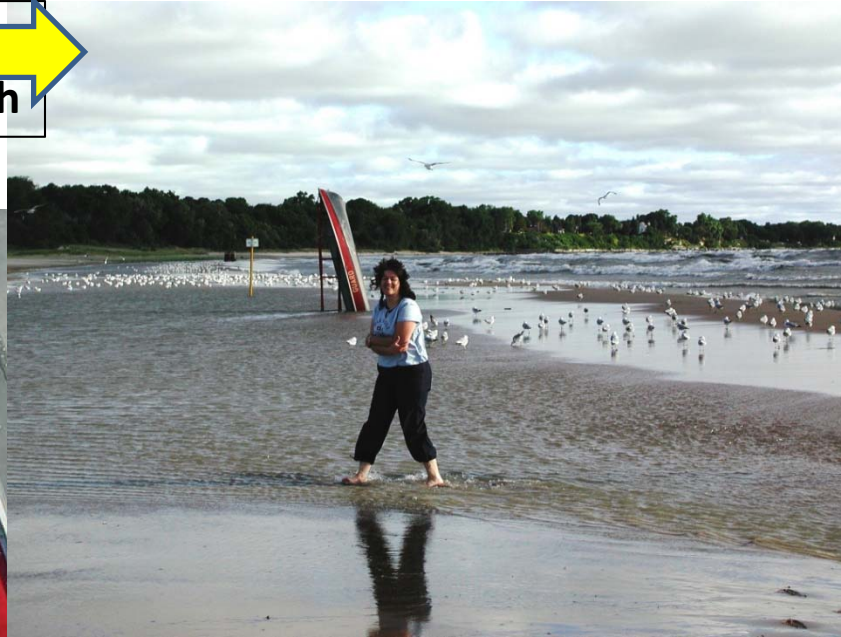
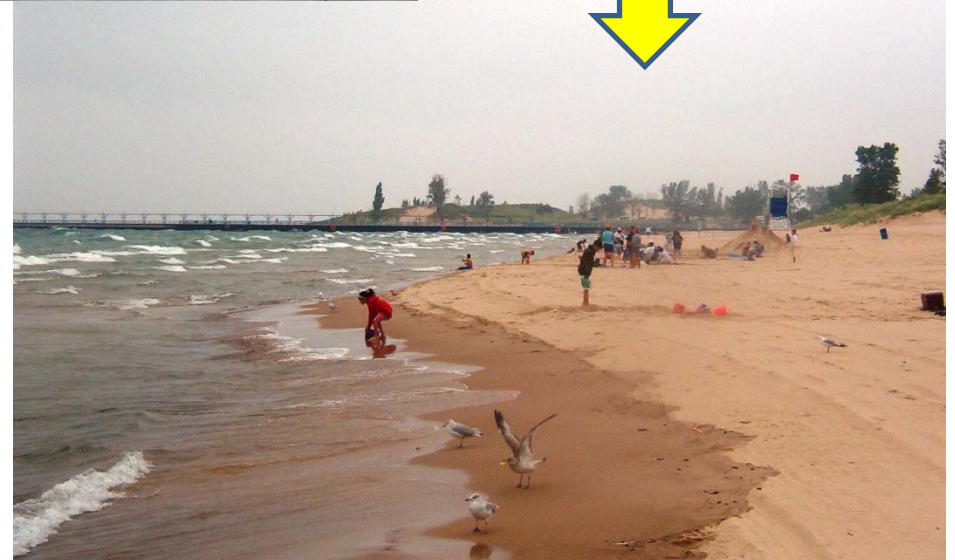
# Improving Beach Slope/Gradient

**TOO FLAT**

**Lots of Water on the Beach**

**HEALTHY**  
**Minimal exchange**
