# **Baseline Assessment of Water Quality**

## **Root River Watershed Restoration Plan**

### **Data Analysis Report**

*2011 – 2013*

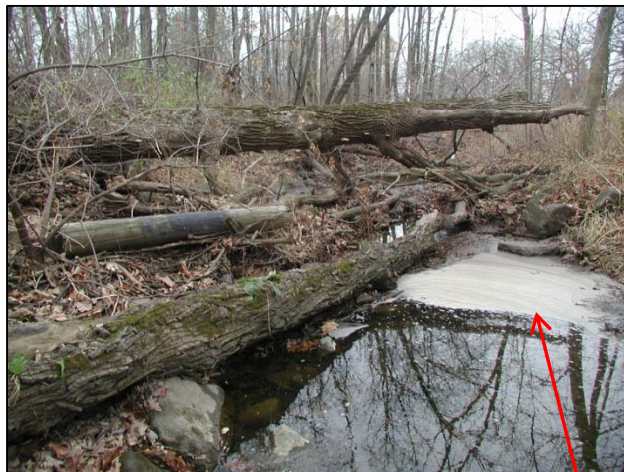
Woody debris buildup with aggregated scum upstream of sampling point.

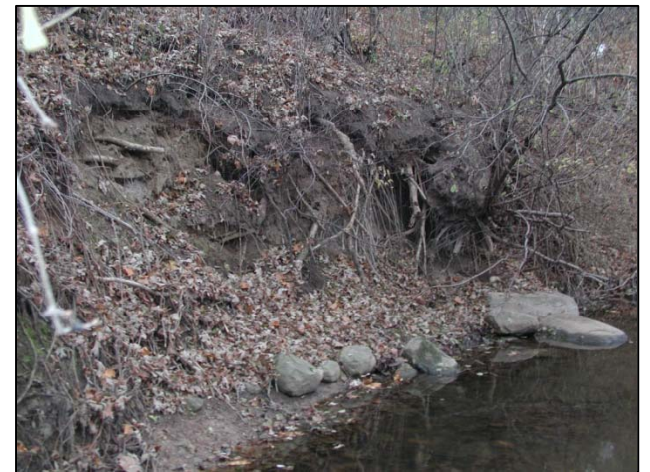
Steep eroded slope located below residential area 50 meters downstream of sampling point.

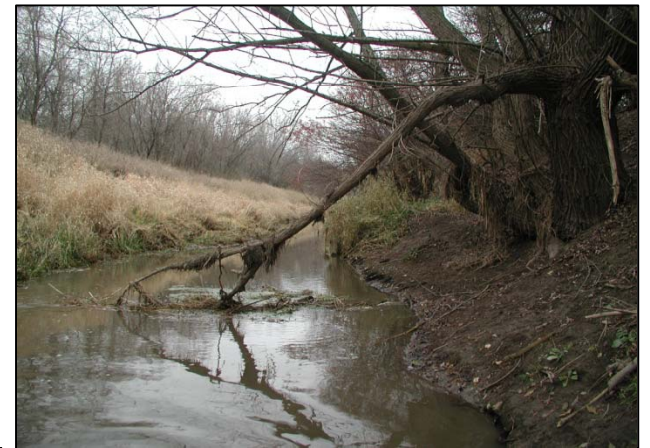
Trees closer than 5 meters to stream bank provide canopy (erosional). Bank with tall grasses show little erosion (depositional).

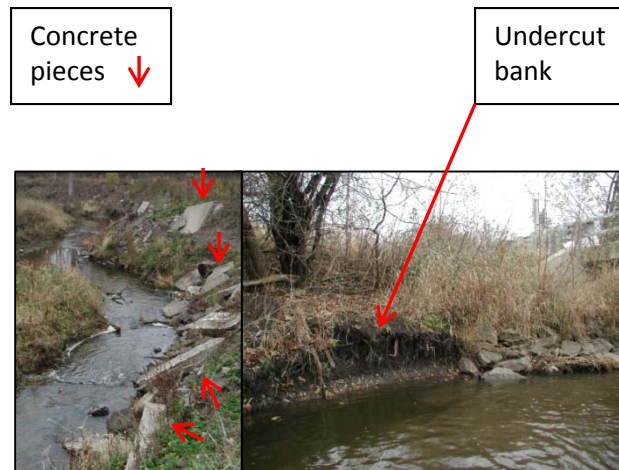
This canal section is classified as Limited Forage Fish. Large pieces of concrete were observed downstream along the east bank, possibly placed as an erosion control measure.

Large pieces of concrete 75 meters downstream of sampling point (left). Eroded undercut banks on upstream west bank (right).

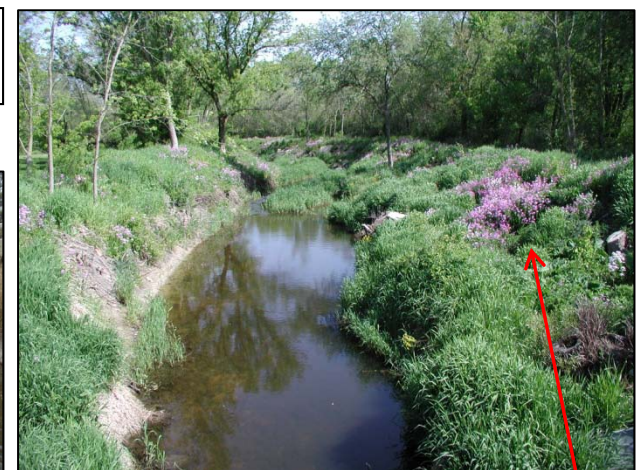
Looking downstream from sampling point in Summer, 2012. Note extensive vegetative growth and purple loosestrife on right bank.

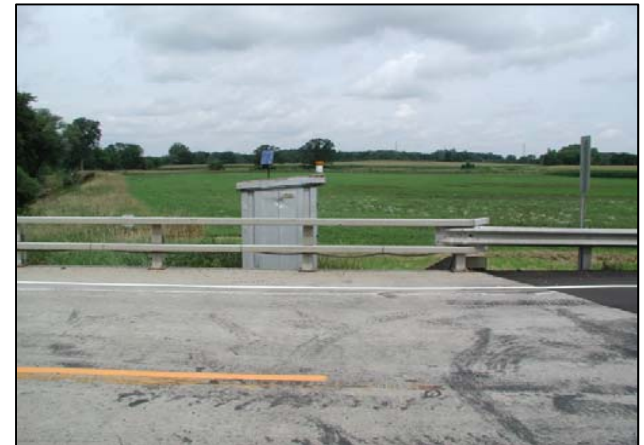
U.S. Geological Survey Discharge Gauging Station on east (right) bank provides continuous volumetric flow rate measurements.

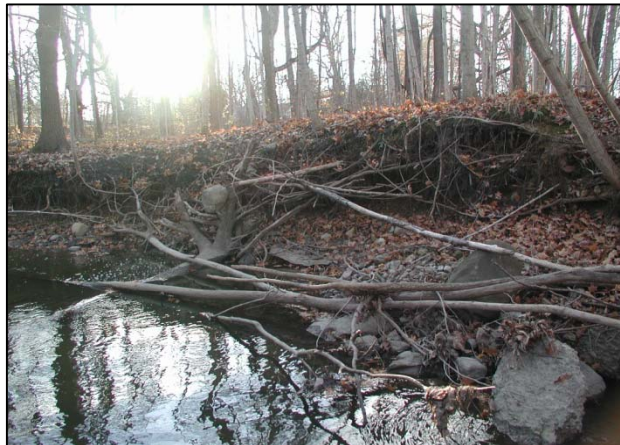
Steep eroded bank upstream of sampling point. Woody debris and various substrate sizes are evident in this habitat.

This tributary section is classified as Limited Forage Fish. Nutrient loading from the upstream WWTP and agricultural production is likely. Stream bank stabilization may help with erosion in high cut areas. Removal of crumbling infrastructure associated with the railway is recommended.

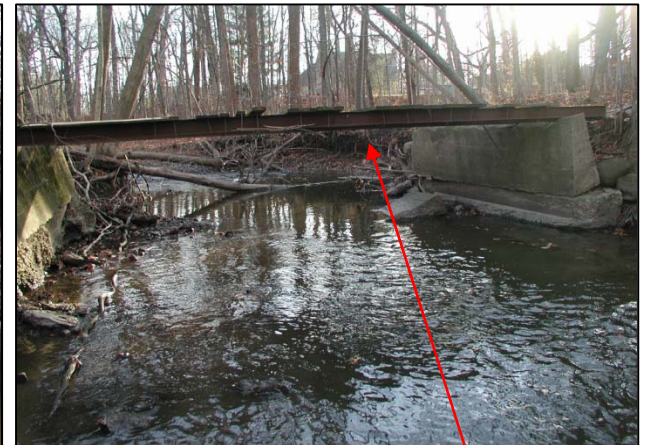
Upstream is an old abandoned rail bridge with crumbling infrastructure.

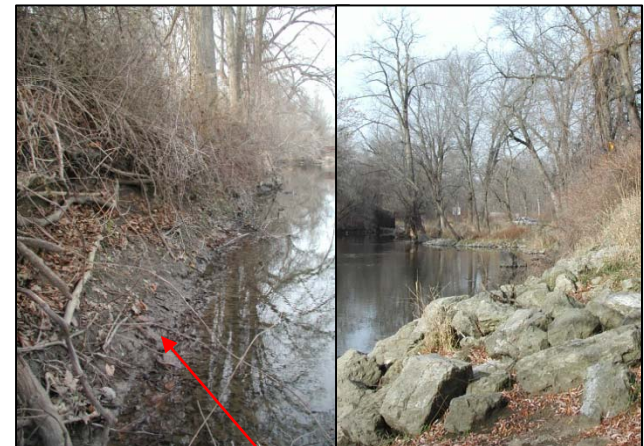
Steep eroded banks (left) at the foot of a bluff with residences on west bank and free-standing rock pilings on east bank next to park (right).

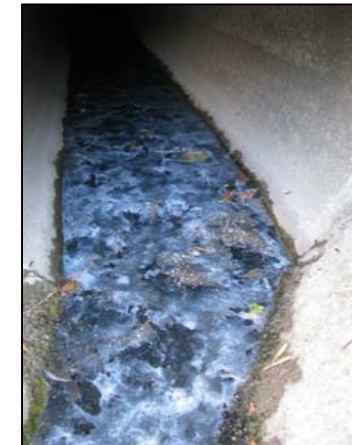
High levels of detergents found in southeast outfall (note foaming present in storm water discharge).
